## Home Inspection Report

5717 Bonita Rd, Lake Oswego , OR 97035

Saturday, October 17, 2015

101715

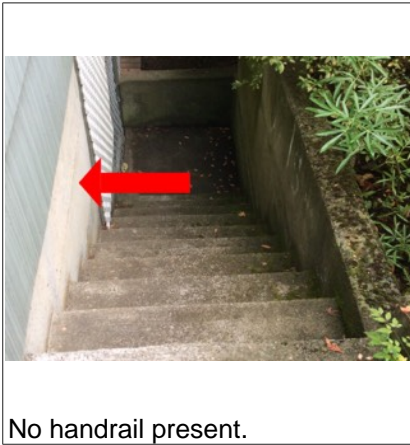
**Comments** [Recommend handrail at outside staircase on east side of house](#)

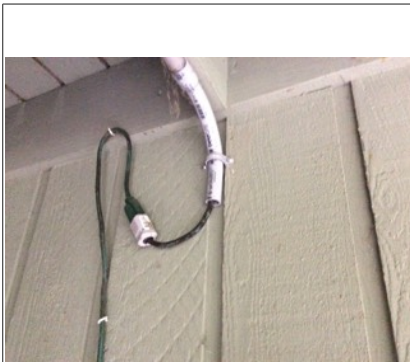
**Comments** [-Typical cracks in concrete, recommend monitoring](#)  
[-Extension cord wiring, recommend repair by qualified electrician](#)

Handyman wiring for sump pump

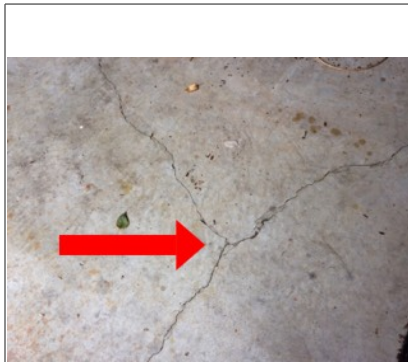
Typical crack at back patio, recommend monitoring.

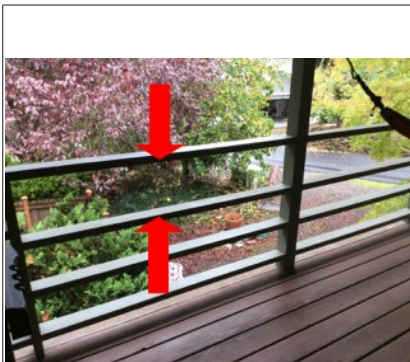
Improper handrail, this is a safety hazard

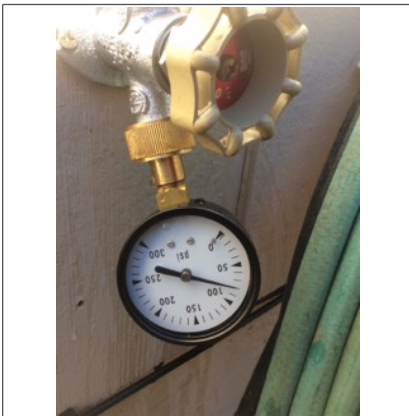
Water pressure measured at 80psi

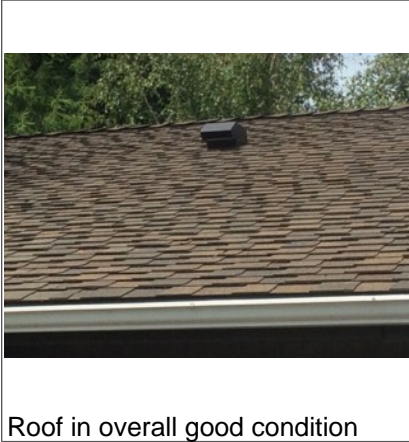
Roof in overall good condition

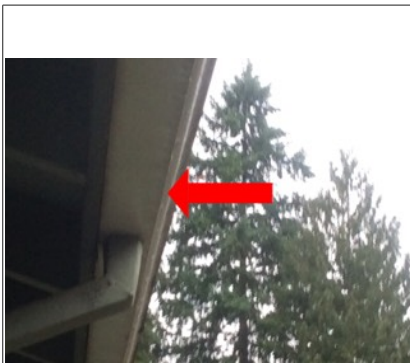
**Comments** [Rain runoff appears to flow over the gutters. Recommend refastening to fascia and monitor.](#)
**Photos**

Rain water dripping over gutter edge

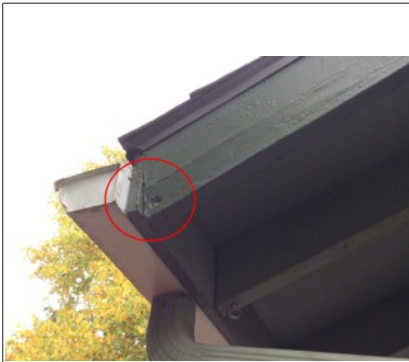
**Material**  None  
 Wood  Fiberboard  Aluminum/Steel  Vinyl  Stucco  Recommend repair/painting  
 Damaged wood  Other  
**Condition**  Satisfactory  Marginal  Poor  
**Comments** Fascia end rotted at south east corner, recommend repair  
**Photos**

Rotted wood on fascia end at south east corner

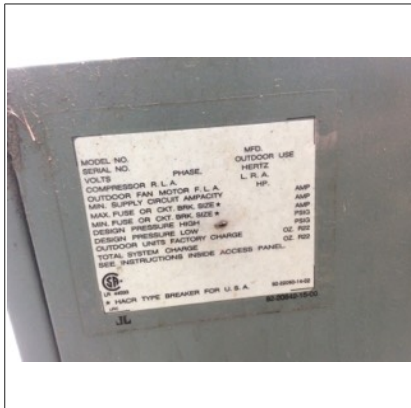
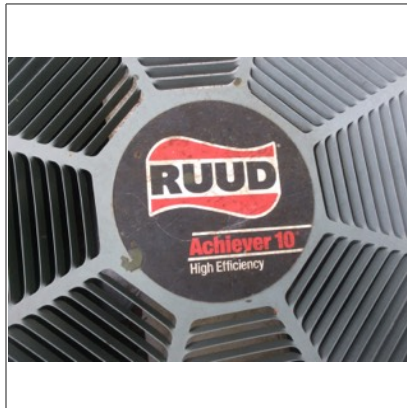
**Unit #1**  N/A  
 Location:  
 West exterior of house  
 Brand:  
 Ruud  
 Model #:  
 1092RPL77564  
 Serial #: 1293D01244  
 Approximate Age:  
 Air conditioner manufactured December 1993, approximately 23 years old  
**Condition**  Satisfactory  Marginal  Poor  Cabinet/housing rusted  
**Energy source**  Electric  Gas  Other  
**Unit type**  Air cooled  Water cooled  Geothermal  Heat pump  
**Outside Disconnect**  Yes  No Maximum fuse/breaker rating (amps): 20amps  
 Fuses/Breakers installed (amps): 20amps  Improperly sized fuses/breakers  
**Level**  Yes  No  Recommend re-level unit  
**Condenser Fins**  Damaged  Need cleaning  Damaged base/pad  Damaged Refrigerant Line  Satisfactory  
**Insulation**  Yes  No  Replace  
**Improper Clearance (air flow)**  Yes  No  
**Photos**

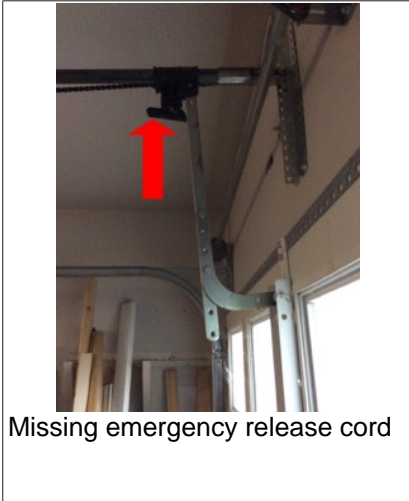
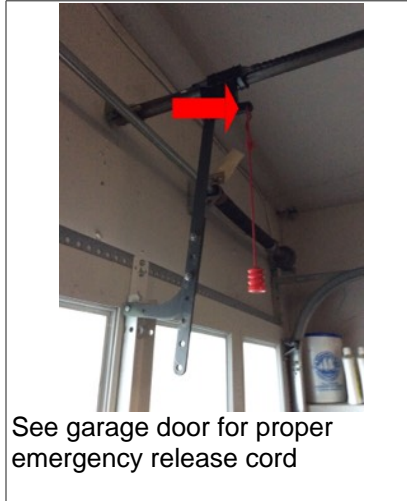
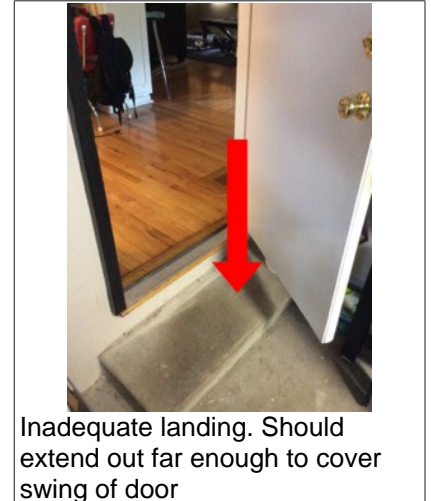
None  
 Attached  Detached  1-Car  2-Car  3-Car  4-Car  Carport  
**Comments** -One of two garage doors missing emergency release cord, safety hazard  
 -Step between garage and living space not adequate, trip hazard

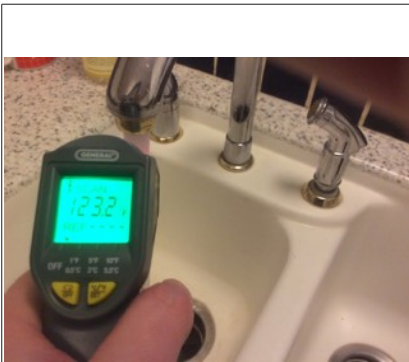
Kitchen faucet (farthest from water heater) reaches 123deg Fahrenheit.

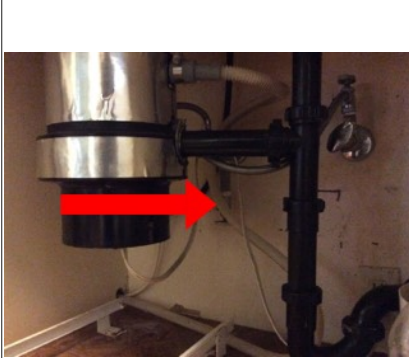
**Comments** Dishwasher drain line not looped beneath countertop. Possible cross contamination, safety hazard

Dishwasher drain line should be looped so sink gray water does not back up into the dishwasher.

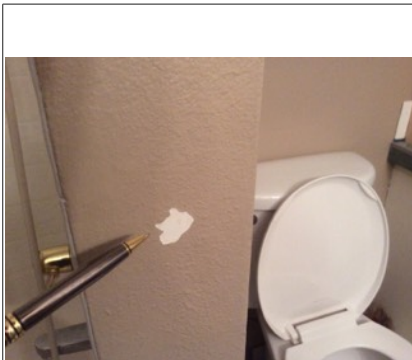
Paint peeling in main level bathroom

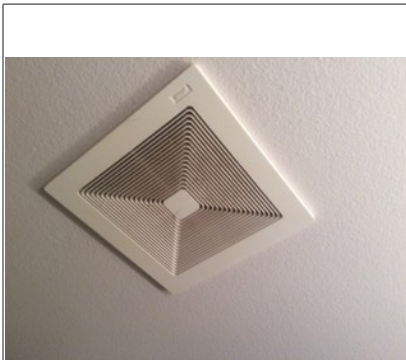
Recommend cleaning vent cover

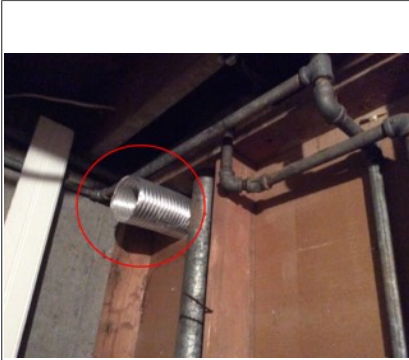
**Comments** Lower level bathroom exhaust fan ducting terminated in adjacent room. Should exhaust to exterior space.  
Recommend repair

Bathroom vent terminated in adjacent room

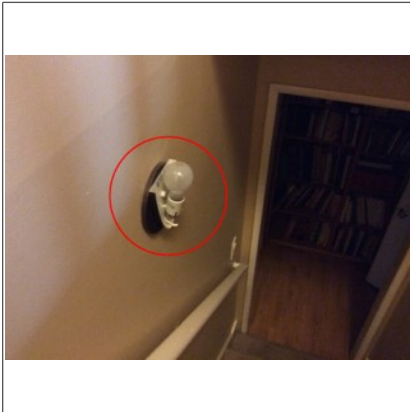
- None
- Condition**  Satisfactory  Marginal  Poor  Loose/Missing
- Handrail**  Satisfactory  Marginal  Poor  Safety hazard  Hand Rail/Railing/Balusters recommended
- Risers/Treads**  Satisfactory  Marginal  Poor  Risers/Treads uneven  Trip hazard
- Comments** Sconce missing shroud or shade, recommend repair
- Photos**

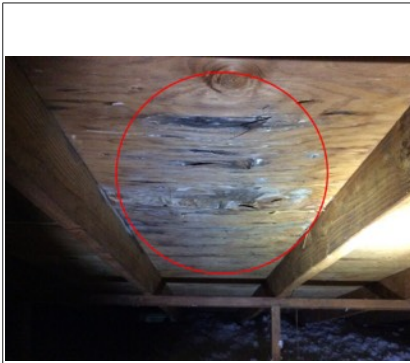
**Comments** -Apparent fixed roof leak, recommend monitoring

Apparent water damage, no new moisture present.

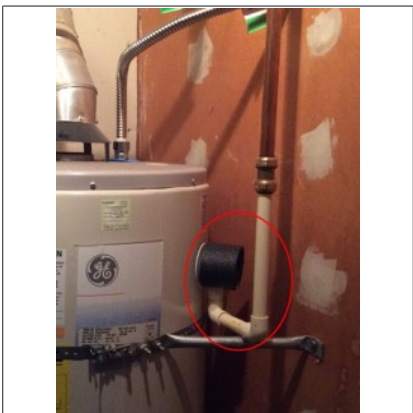
**Type**  Gas  Electric  Oil  LP  Other  
**Combustion air venting present**  Yes  No  N/A  
**Seismic restraints needed**  Yes  No  N/A  
**Relief valve**  Yes  No Extension proper:  Yes  No  Missing  Recommend repair  Improper material  
**Vent pipe**  N/A  Satisfactory  Pitch proper  Improper  Rusted  Recommend repair  
**Condition**  Satisfactory  Marginal  Poor  
**Comments** **Pressure relief valve extension on water heater should exit the tank and go straight down to be uncapped 6" off of the floor**

Improper pressure relief extension off of water heater

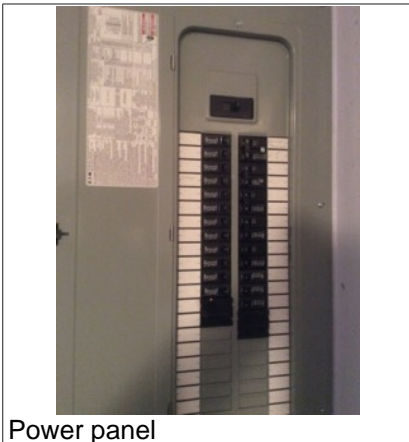
Power panel

**Comments** Recommend labeling breakers in power panel.

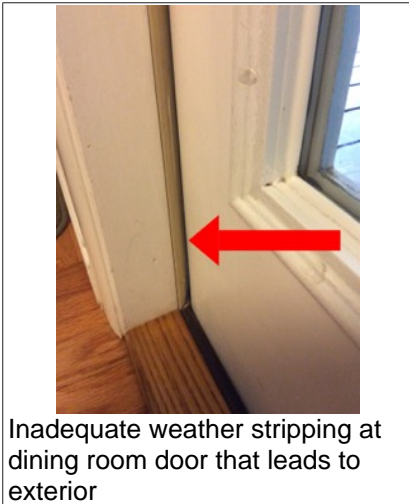
**Comments** Inadequate weather stripping at dining room door that leads to exterior
